Fire Patterns Analysis with Low Heat Release Rate Initial Fuels

Keywords: fire patterns, fire effects, compartment fires, fire investigation

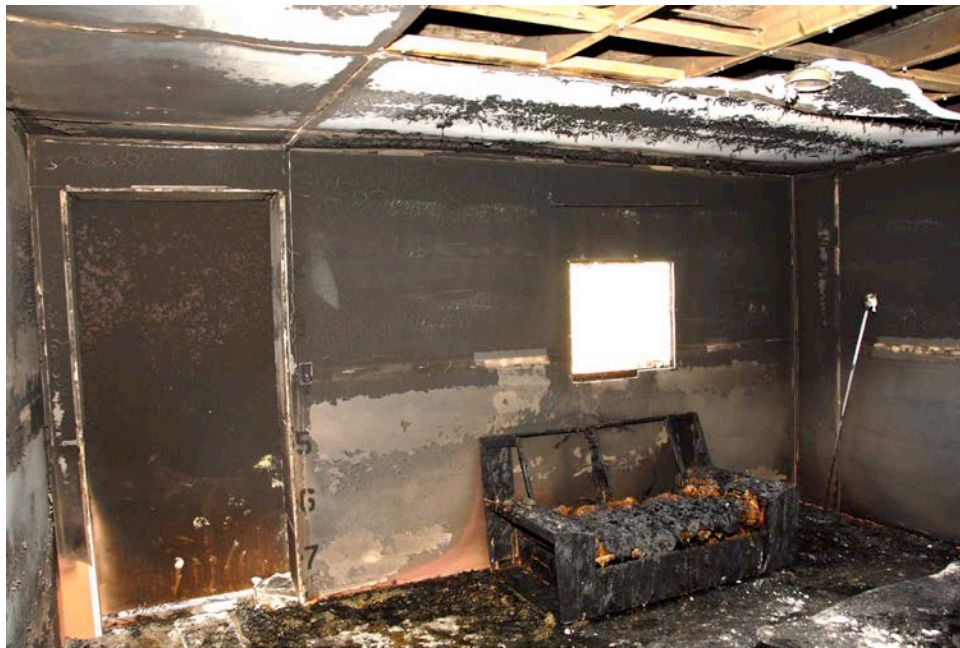
Figure 6. North Wall - Test 1 (Sofa Origin)

The north wall exhibits heavy to severe damage across its entire surface from the ceiling to approximately a foot off the floor. There is a protected area located behind the loveseat. The entire width and height of drywall above the seam is heavily damaged with the paper consumed and the gypsum wallboard changing to a black or dark grey color. The greatest visible damage is the severe damage that extends from the floor to the drywall seam between the doorway and the loveseat (Figure 6).

The vertical cushion for the backrest of the loveseat is completely consumed and the finishing fabric along the horizontal cushion has been consumed, however, the horizontal padding is still present. The loveseat has relatively uniform damage extending from the top of the backrest down to the horizontal cushions. The kickboard of the loveseat is uniformly charred both in width and height. The back face of the sofa was protected and displays no thermal effects. The left armrest of the sofa, nearest the door, has char greater and lower in elevation than the right armrest.

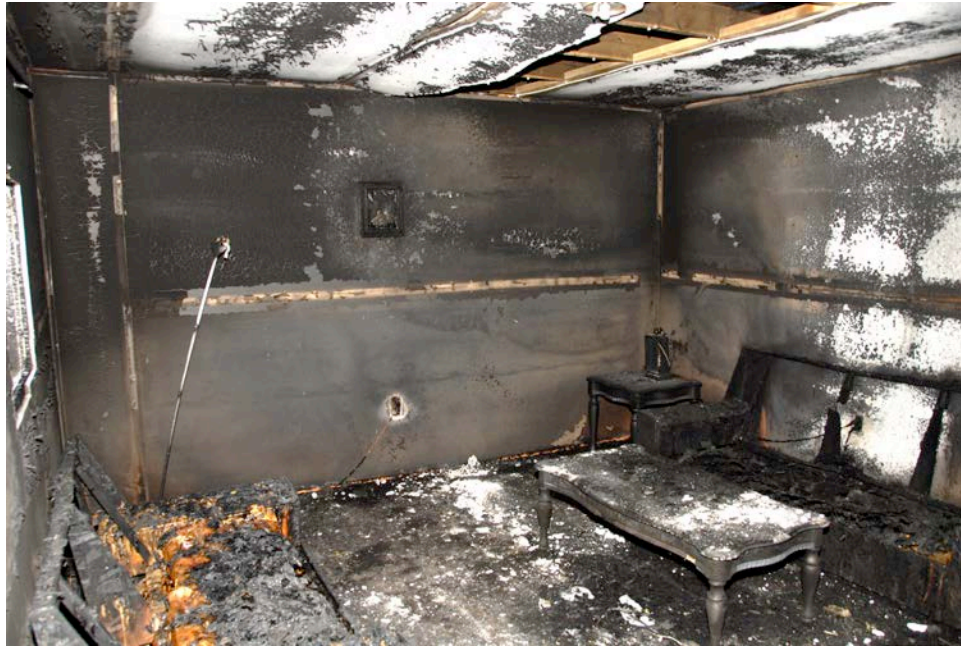
Figure 7. East Wall - Test 1 (Sofa Origin)

The east wall has moderate damage along the upper portions of the entire wall, minor damage below the drywall seam, and heavy damage in the south corner nearest the sofa (Figure 7).

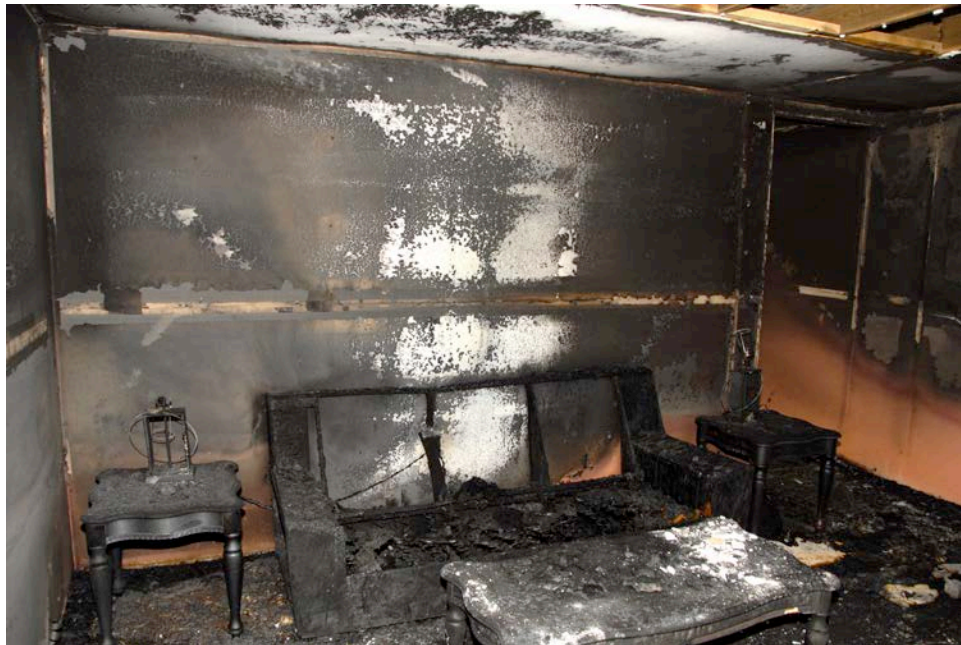
Figure 8. South Wall - Test 1 (Sofa Origin)

The south wall has the greatest degree of visible damage comparative to all other walls (Figure 8). Damage in the center of the wall extends from floor to ceiling. Increasing lines of demarcation move outward from the center of the wall towards the hallway and east wall. The greatest area of clean burn in the compartment is witnessed in the center of the wall extending from floor to ceiling. Protected areas are witnessed behind each of the end tables.

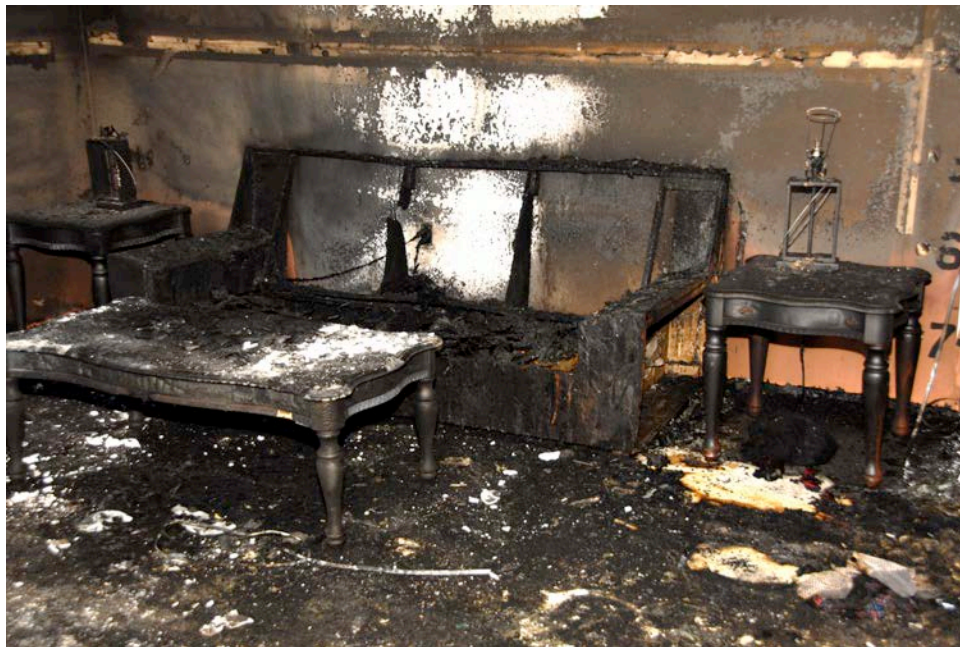
Figure 9. Sofa and Tables - Test 1 (Sofa Origin)

The sofa that was located along the south wall had near complete consumption of its cushions and complete consumption of its finishing fabric. The majority of the wood frame remains intact, except for the center-left vertical backrest support. The left end (east) of the sofa exhibits complete loss of padding, while the right end (west) of the sofa still has a small amount of padding remaining. The interior sides of both armrests have significantly greater charring versus the exterior sides. The kickboard has greater charring and mass loss in the center and lesser damage towards each end. The sofa was damaged considerably more than the loveseat and the other contents within the compartment (Figure 9).

The laminate wood veneer coating covering the top of the coffee table has greater loss of mass on the side nearest the sofa. The lateral support facing the sofa, visibly appears to have greater and deeper charring (i.e. deeper and more cracks in the wood) than the other faces. The legs closest to the sofa visibly appear to have greater and deeper charring near the side of the sofa, while the legs opposite the sofa exhibit lesser damage. The interior of the legs and the underside of the table have received only slight thermal damage (Figure 9).

The right end table (west of sofa) has greater damage on the left face, nearest the sofa. The veneer has begun to peel off and mass has been lost. The front face of this end table exhibits lesser damage to its veneer than the left face. The veneer on the back and right side of the end table exhibit no thermal damage (Figure 9).

The left end table (east of sofa) has greater damage on the right side nearest the sofa. The right face of the table is the only side that exhibits any damage to the veneer (Figure 9).

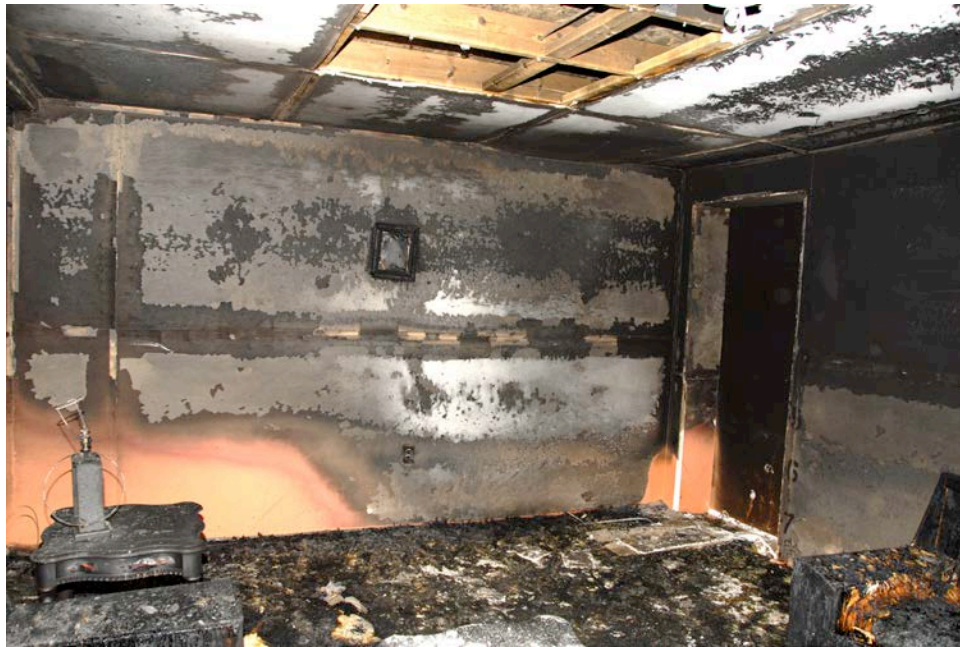
Figure 10. West Wall - Test 1 (Sofa Origin)

The south end of the west wall has moderate to heavy damage with an increasing line of demarcation as one moves down the hallway (Figure 10). The north end of the west wall (nearest the door) has heavy to severe damage extending from floor to ceiling. In addition, there is an area of clean burn located off the floor between 3 and 5 feet that extends 5 feet into the compartment from the doorway.

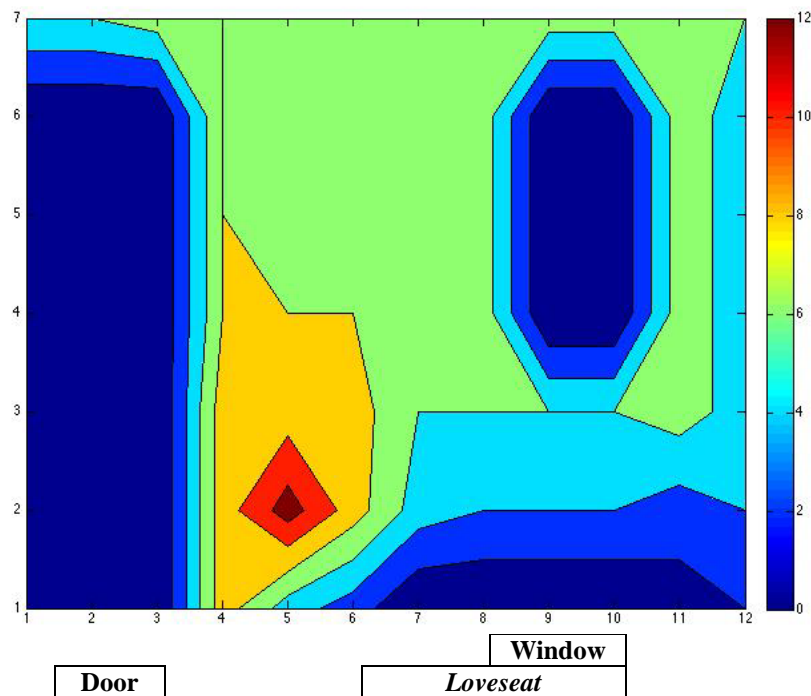
Figure 11. North Wall - Test 1 (Sofa Origin)

The greatest depth of calcination along the north wall was located next to the doorway (Figure 11). The remainder of the wall appears to have similar depth measurements, with slightly greater depths also around the window.

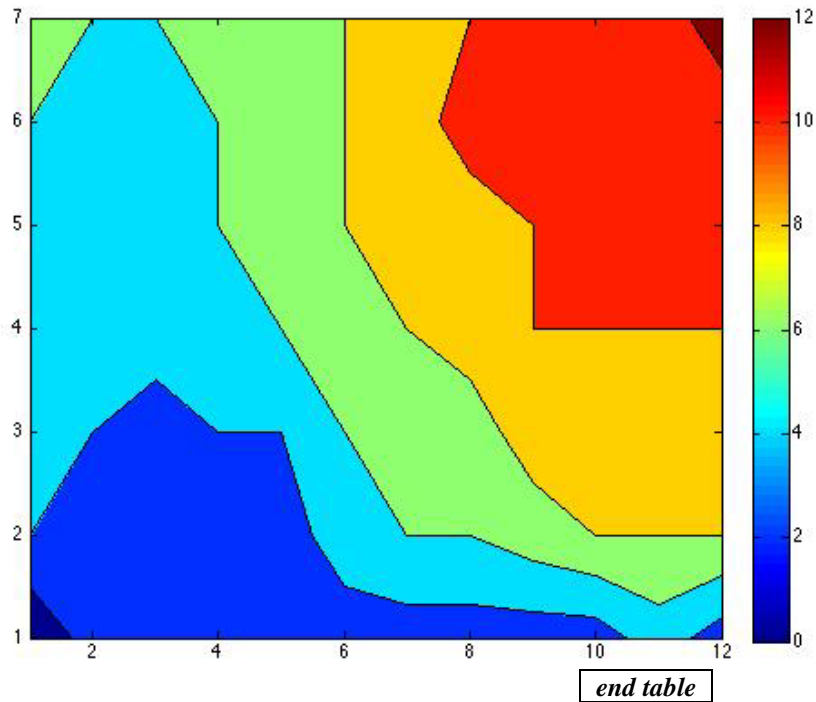
Figure 12. East Wall - Test 1 (Sofa Origin)

The greatest depth of calcination along the east wall was located in the south corner above the end table and sofa (Figure 12). This is most likely due to the ceiling jet and collection of upper layer gases in this corner from the fire plume on the sofa.

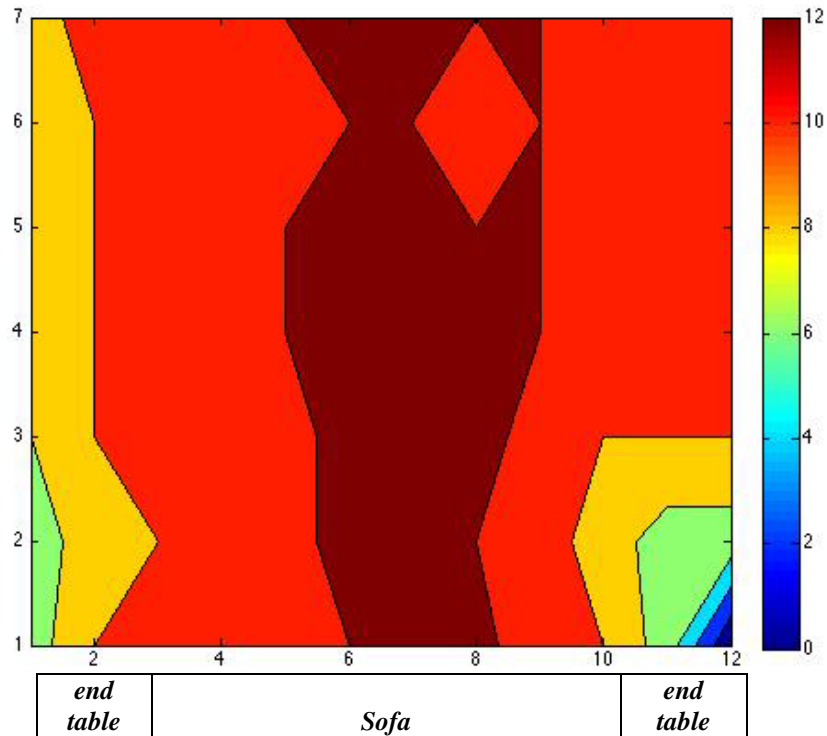
Figure 13. South Wall - Test 1 (Sofa Origin)

The south wall had the deepest measurements and the greatest area of calcined material in the compartment (Figure 13). The greatest depth measurements were found in the center of the wall, with several measurements going completely through the wallboard directly behind the center of the sofa. The depth measurements lessened towards the hallway and east walls. The greater depth measurements were expected along this wall due to sofa being the first fuel ignited and largest fuel in the compartment.

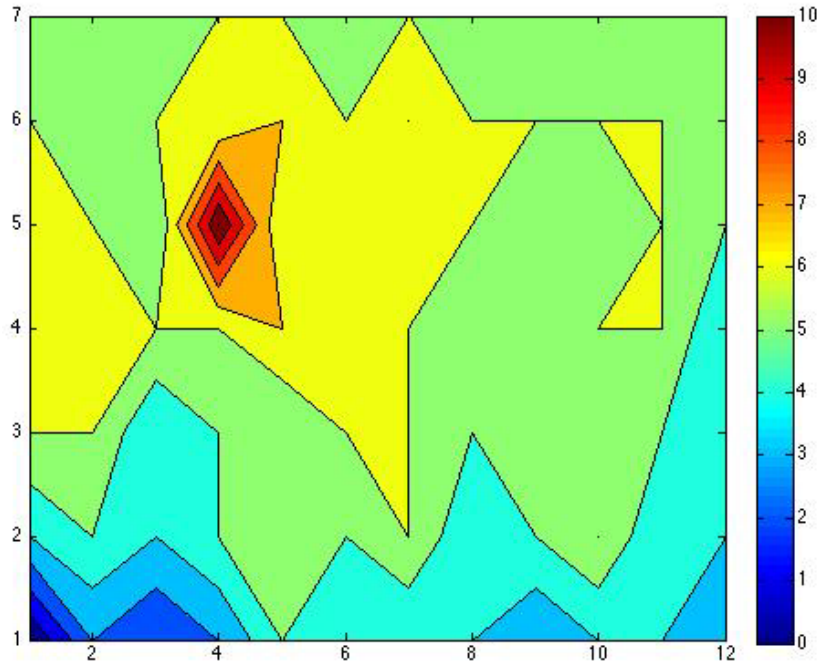
Figure 14. West Wall - Test 1 (Sofa Origin)

The greater depth of calcination measurements along the west wall was located above the drywall seam. The depth of calcination along this wall was lesser in comparison to the other walls (Figure 14). The significant visible damage noted in Figure 10 was not illustrated to the same extent in the depth of calcination measurements (Figure 14). This possibly indicates that the surface of the wallboard was influenced by the ventilation-controlled combustion at this location, but the total heat transfer into the wall was significantly less due to a shorter duration and/or less intense heat flux. Resulting in a pronounced visible damage, but not reflected to the same extent in the measurable damage.

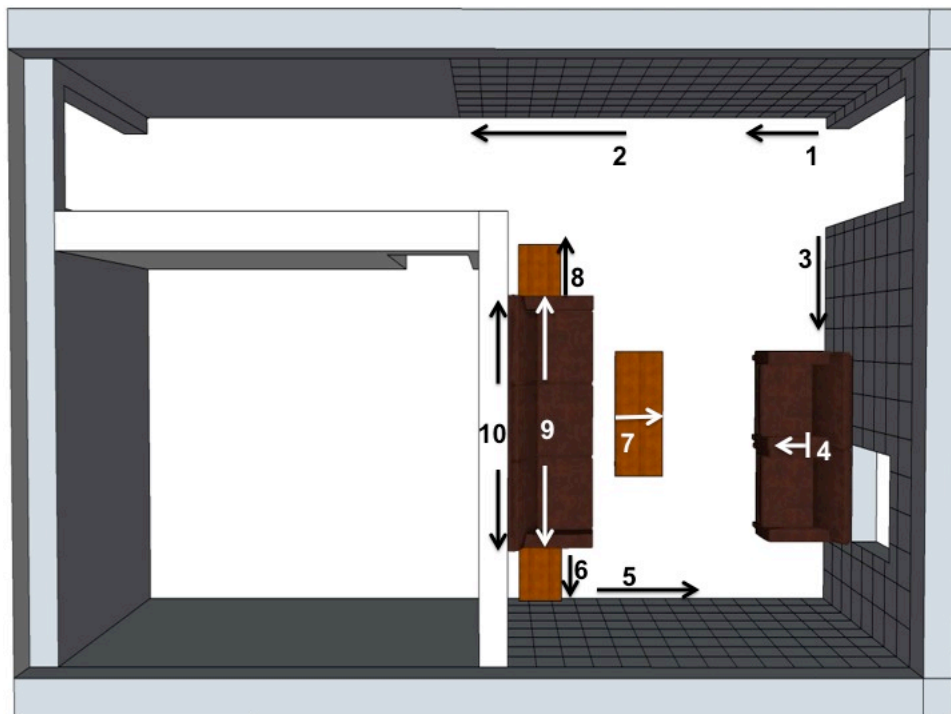
Figure 15. Heat and Flame Vector Analysis Diagram - Test 1 (Sofa Origin)

The heat and flame vector analysis diagram indicates two areas within the compartment where damage emanates (Figure 15, Table 4). The majority of the damage within the compartment can be traced back to the center of the sofa. However, there is damage that appears to emanate from the location of the door opening.

Based on the heat and flame vector analysis, there are two hypothetical areas of origin that must be evaluated (1) the center of the sofa, and (2) the location around the doorway. As this compartment was ventilation-controlled for some time, the damage around the open ventilation source is expected and should not warrant a significant weighting in the analysis of the area of origin [8]. In addition, an origin determination should also evaluate the first fuel ignited and the presence of a competent ignition source within those hypothetical areas of origin. At the doorway location, there is neither a first fuel nor a competent ignition source, further decreasing the weight of this hypothetical area of origin.

The second area of origin hypothesis is much more plausible and supported by the compartment fire dynamics. The complete loss of mass to the sofa, the directional damage to the surrounding tables emanating from the sofa, the greatest visible and measurable damage located along the south wall directly behind the sofa, and most importantly the sofa being a plausible fire scenario that was capable to cause the resulting damage and fire

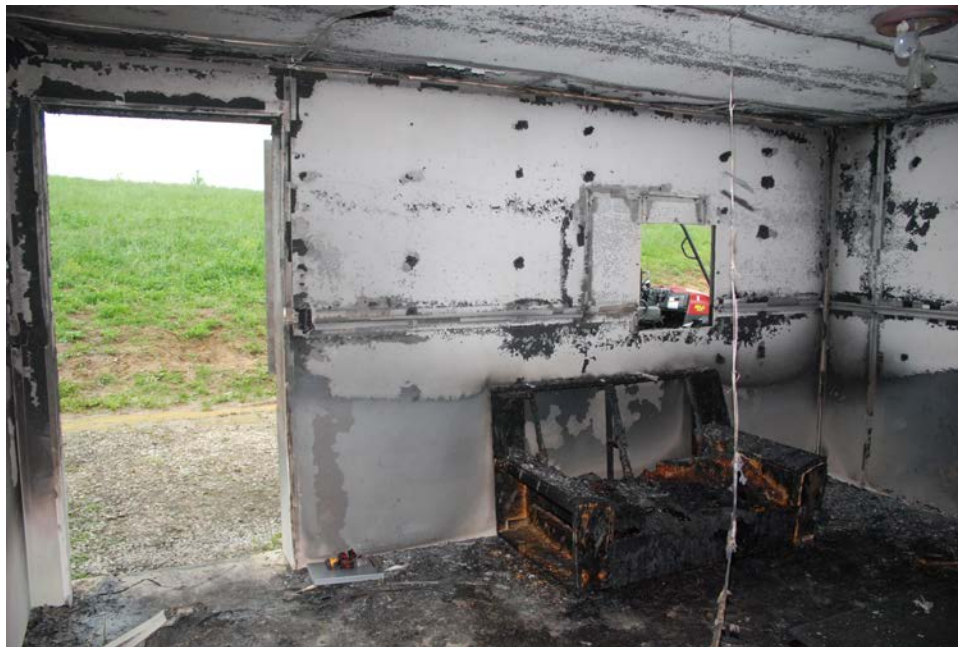
Figure 18. North Wall - Test 2 (End Table Origin)

The north wall has a uniform line of demarcation approximately three feet off the floor that separates clean burning to the upper portions of the wall and paper consumption in the lower portions (Figure 18).

Identical to test 1, the vertical cushion for the backrest of the loveseat is completely consumed and the finishing fabric along the horizontal cushion has been consumed, however, the horizontal padding is still present. The loveseat has relatively uniform damage extending from the top of the backrest down to the horizontal cushions. The kickboard of the loveseat is uniformly charred both in width and height. The back face of the sofa was protected and displays no thermal effects. The left side of the sofa, the side near the door, has char greater and lower in elevation than the right side.

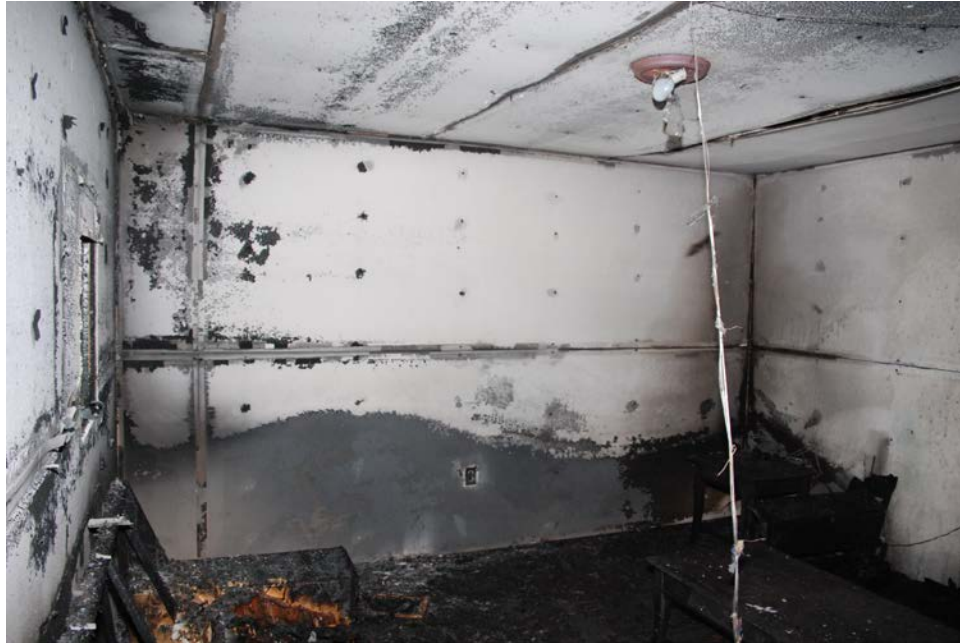
Figure 19. East Wall - Test 2

The east wall has a roughly uniform line of demarcation separating the upper portions of the wall that have significant clean burning from the lower portions of the wall that have charred craft paper only (Figure 19). The line of demarcation is lowest in the south corner, near the sofa.

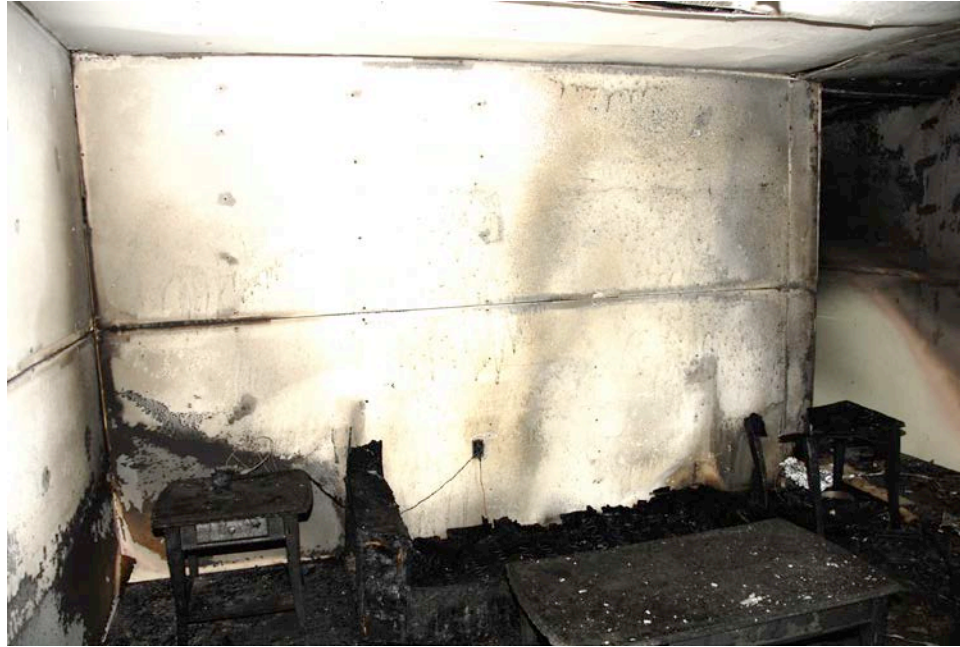
Figure 20. South Wall - Test 2 (End Table Origin)

The south wall has the most severe damage and greatest area of clean burning within the compartment (Figure 20). The clean burn damage extends from floor to ceiling starting from the west end of the wall to approximately the left armrest of the sofa. An increasing line of demarcation extends from the left end of the sofa to the east wall, with clean burn damage above this line and a protected area behind the left end table (east).

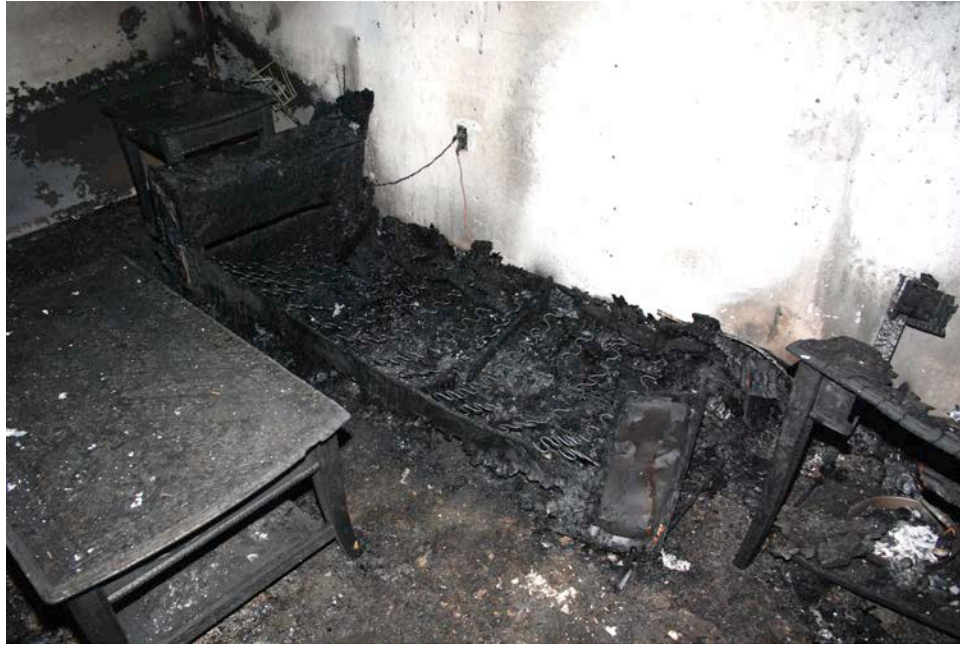
Figure 21. Sofa and Tables - Test 2 (End Table Origin)

The sofa that was located along the south wall had complete consumption of its cushions, finishing fabric, and wooden backrest support. The right arm of the sofa has also lost the majority of its mass and structural integrity. The left arm of the sofa has significant char on the interior face, while the exterior face has only slight char. The kickboard has progressively greater mass loss and charring on the right side versus the left. The sofa had considerably greater damage than the loveseat (Figure 21).

The lateral support of the coffee table closest to the sofa visibly appears to have greater and deeper charring (i.e. deeper and more cracks in the wood) than the other surfaces. The legs closest to the sofa visibly appear to have greater and deeper charring, while the legs opposite the sofa exhibit lesser damage. The leg closest to the right side of the sofa has the greatest damage. The interior of the legs and the underside of the table have received only slight thermal damage (Figure 21).

The right end table (west of sofa) has the greatest charring and loss of mass compared to any of the other tables. The top of the table has lost most of its mass. The left lateral support (left face) has been completely consumed. The front and back faces have significant mass loss and deep charring. The right face has only slight charring. The left side legs, both their interior and exterior faces, have deep charring and significant mass loss. The right side legs have deep charring on the interior faces, but limited thermal damage to their exterior faces. The right end table had considerably greater damage compared to the other tables within the compartment (Figure 21).

The left end table (east of sofa) exhibits greater damage on the right side nearest the sofa. The right face of the table is the only side that exhibits any thermal damage (Figure 21).

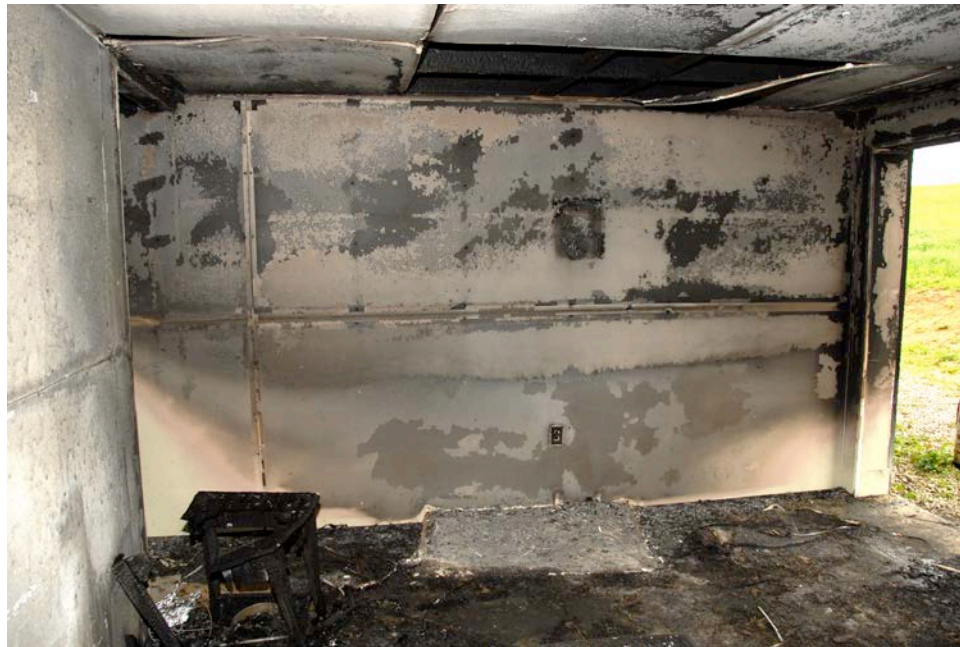
Figure 22. West Wall - Test 2 (End Table Origin)

The upper half of the west wall has clean burn damage (Figure 22). The lowest area of clean burn starts approximately one foot below the drywall seam and extends from the doorway to approximately 9 feet into the compartment. Near the center of the wall is the lowest area of damage that extends from floor to ceiling. On either side of this area are increasing lines of demarcation moving towards the door and down the hallway.

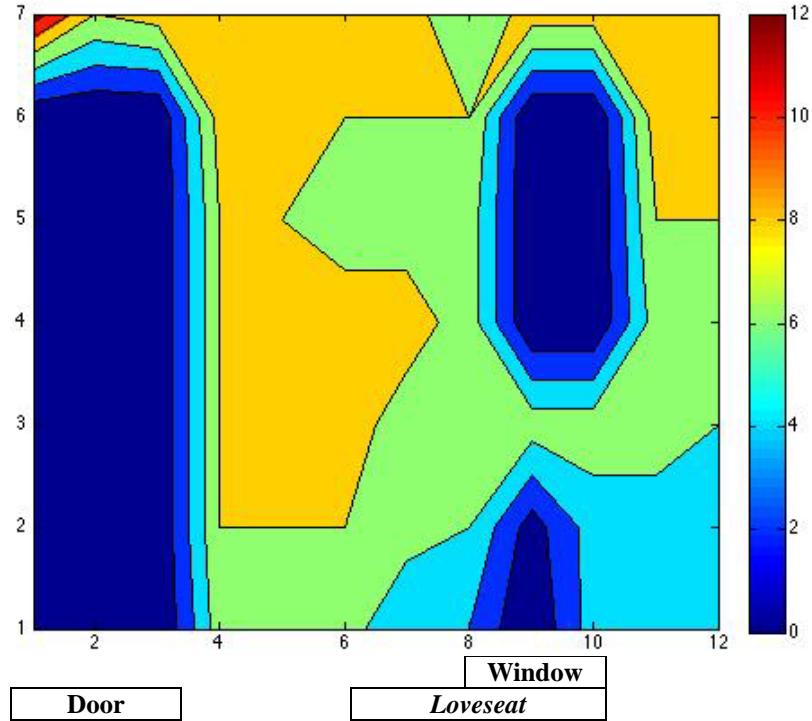
Figure 23. North Wall - Test 2 (End Table Origin)

The greatest depth of calcination along the north wall was located around the doorway and the window (Figure 23).

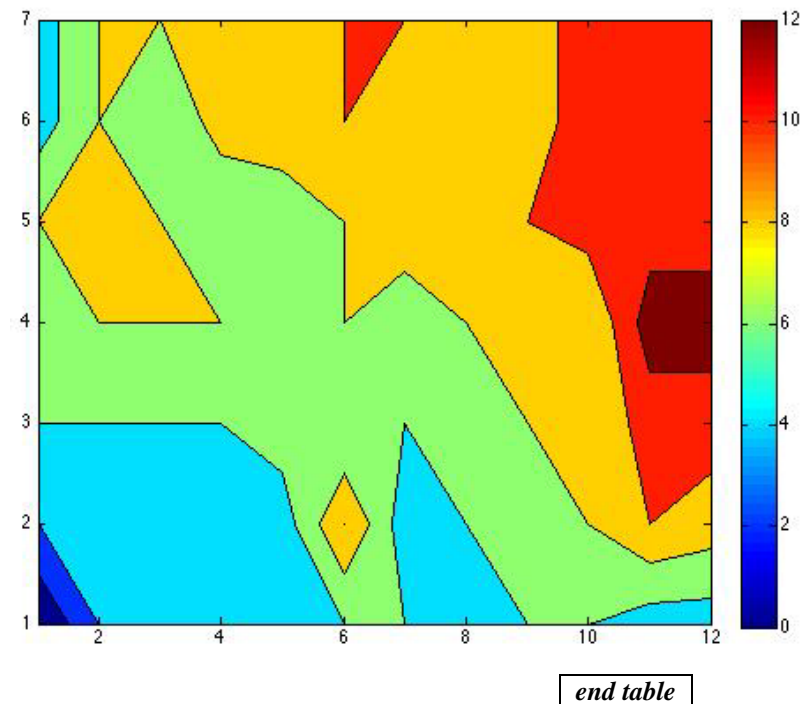
Figure 24. East Wall - Test 2 (End Table Origin)

The greatest depth of calcination along the east wall is located in the south corner above the the end table and sofa (Figure 24). This was most likely caused by the ceiling jet and upper layer gases forming in this corner.

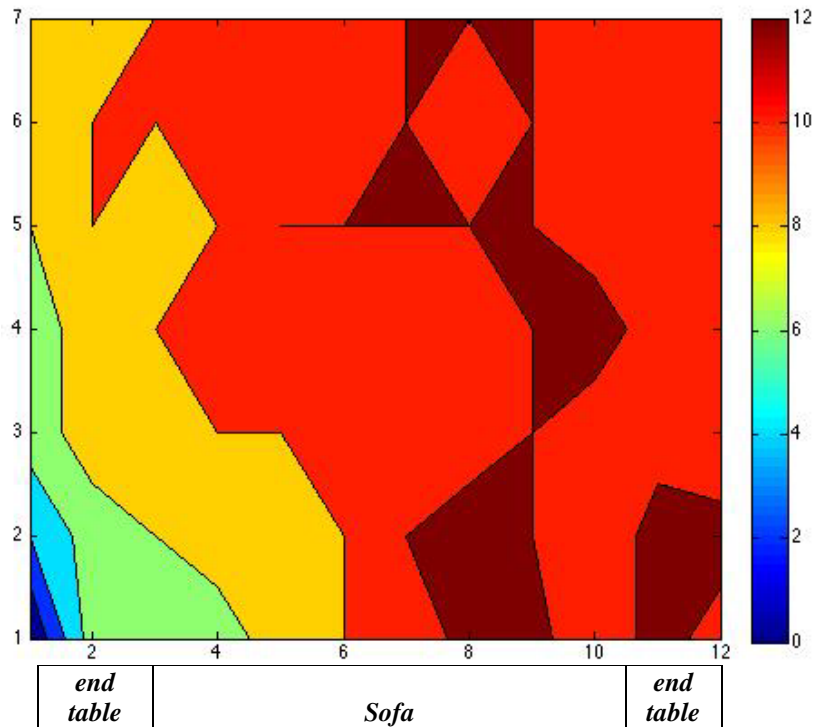
Figure 25. South Wall - Test 2 (End Table Origin)

The greatest depth measurements and the greatest area of calcined wallboard was located on the south wall (Figure 25). The right side and center of the wall had the greatest depth measurements, with several measurements going completely through the wallboard directly behind the right end table and right side of the sofa. The measurements were less towards the east wall.

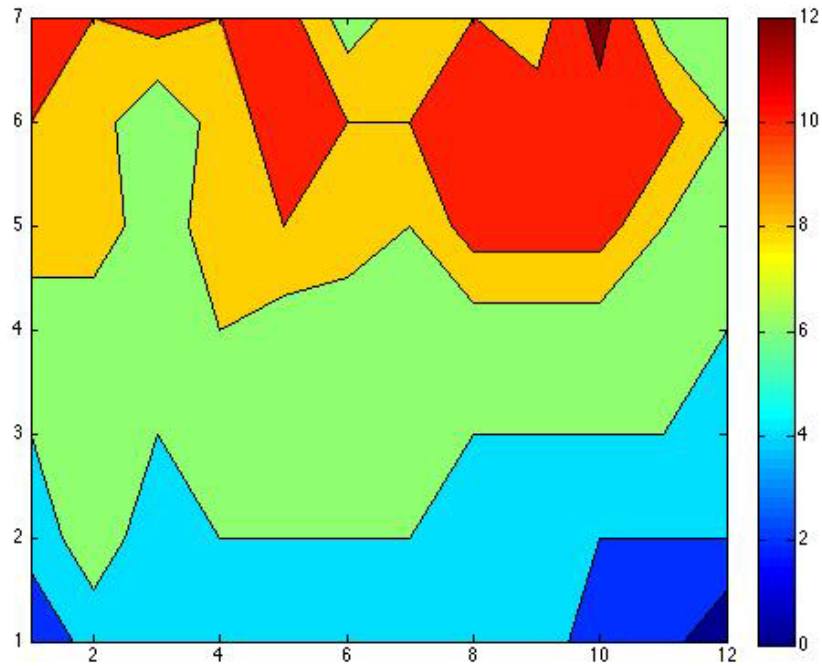
Figure 26. West Wall - Test 2 (End Table Origin)

The greatest depth of calcination measurements along the west wall were found above the drywall seam nearest the doorway (Figure 26).

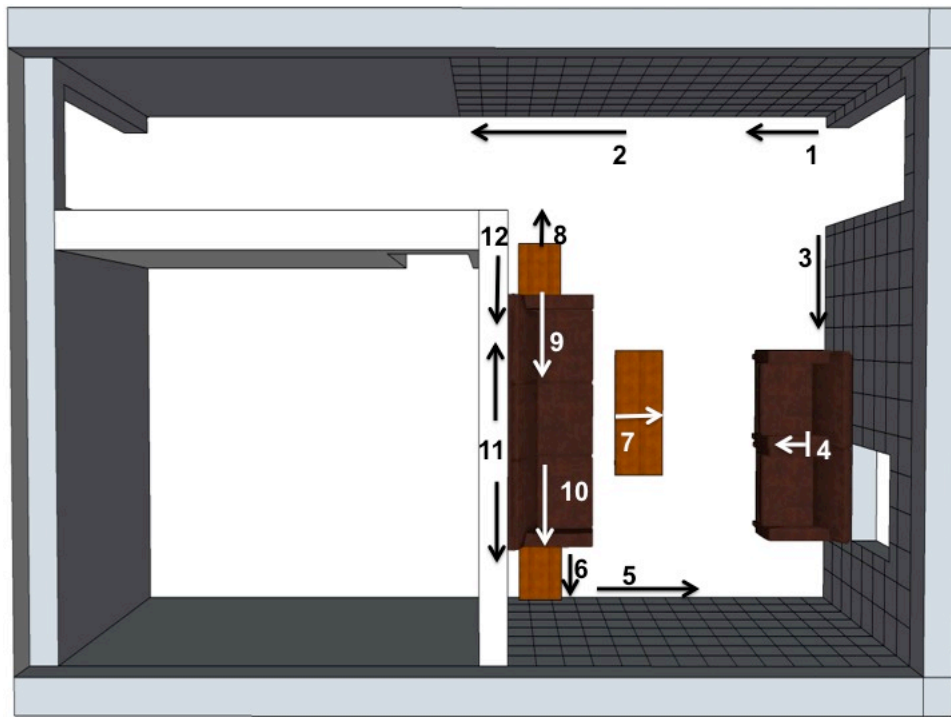
Figure 27. Heat and Flame Vector Analysis Diagram - Test 2 (End Table Origin)

The heat and flame vector analysis diagram indicates three areas within the compartment where damage emanates (Figure 27, Table 5). The majority of the damage within the compartment can be traced back to the right side of the sofa and/or the right end table. However, similar to test 1, there is damage that appears to emanate from the location of the door opening.

Based on the heat and flame vector analysis, there are three hypothetical areas of origin that must be evaluated (1) the right side of the sofa, (2) the right end table, and (3) the location around the doorway. As discussed in the previous test, this compartment was ventilation-controlled for some time. Therefore, the damage around the open ventilation source is expected and should not warrant a significant weighting in the analysis of the area of origin [8].

The most noteworthy damage is the deep calcination measurements behind the right end table, the near complete loss of mass to the right end table, and the progression of fire travel across the sofa from the right end should lead the investigator to the right end table as the first fuel ignited.
