Fire Patterns Analysis with Low Heat Release Rate Initial Fuels

Keywords: fire patterns, fire effects, compartment fires, fire investigation

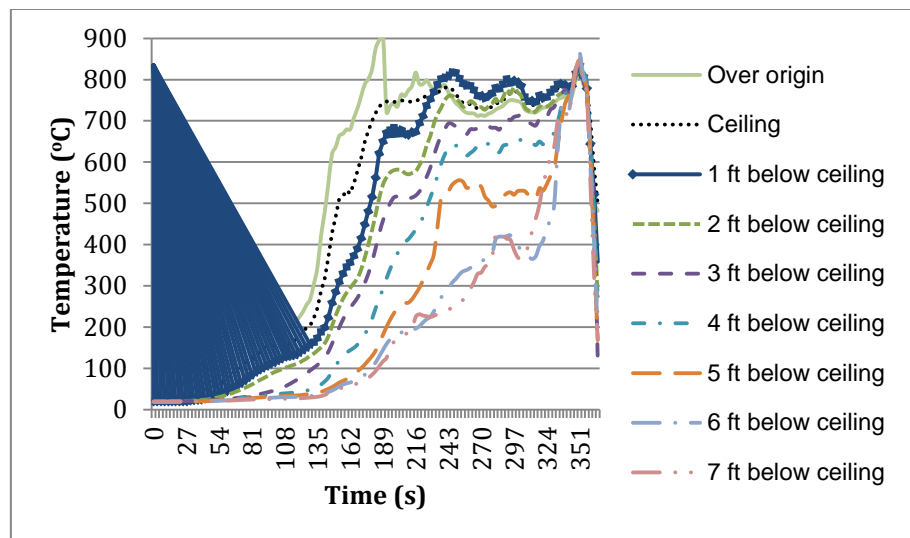
Figure 4. Test 1 Temperature Measurements – Sofa Origin

Test one was conducted on March 17, 2010. This test lasted for approximately six minutes with the window failing around 250 seconds, flashover occurring around 310 seconds, and extinguishment at 370 seconds. Flashover was determined visually by the ignition of the carpet inside the doorway and by the presence of flaming combustion exterior of the compartment through the window and doorway. This timing was confirmed by two technical indicators for flashover, an upper layer temperature of 600°C and a heat flux of 20 kW/m² at the floor level (Figures 4-5).

Temperatures were in excess of 300°C for approximately 200 seconds. Heat flux values in excess of 55 kW/m² were found to exist at the floor level.

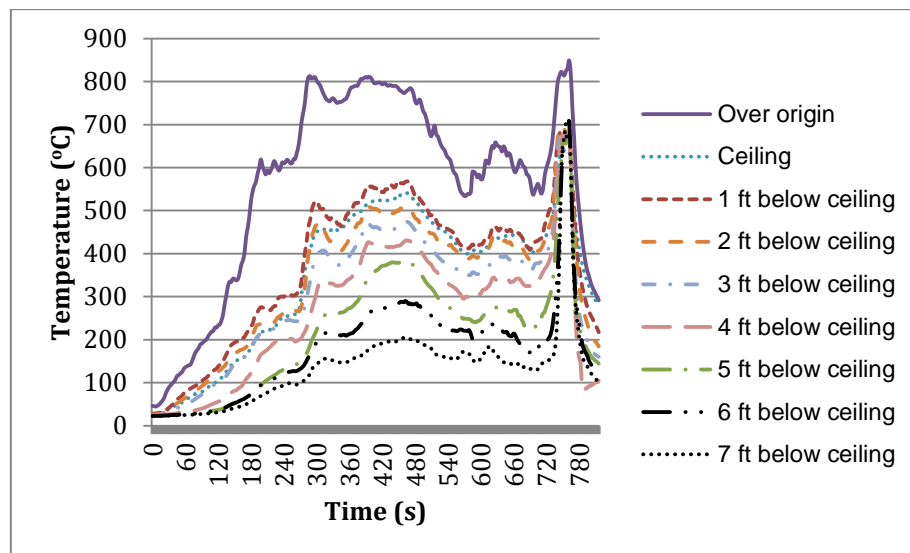
Figure 16. Test 2 Temperature Measurements – End Table Origin

Test two was conducted on April 26, 2011. This test lasted for approximately 13 minutes and 20 seconds with the window failing around 570 seconds. The time to flashover is somewhat debatable due to the mixture of indicators witnessed. The technical indicators for flashover including a heat flux of 20 kW/m², temperatures in the upper layer nearing 600 °C, and persistent flames exiting the door opening were witnessed at 380 seconds, but the fire became ventilation-controlled and began to decay shortly after this. Once the window failed, the fire again began to grow, with extinguishment taking place at approximately 800 seconds. Flashover was determined visually by the ignition of the carpet inside the doorway and by the presence of flaming combustion exterior of the compartment through the window and doorway. This timing was confirmed by two technical indicators for flashover, an upper layer temperature of 600°C and a heat flux of 20 kW/m² at the floor level (Figures 16-17).

Temperatures were in excess of 300°C for approximately 500 seconds. Heat flux values in excess of 70 kW/m² were found to exist at the floor level. These readings may be higher due to the proximity of the heat flux transducer to the initial fuel items.
